PUTNAM LAKE DAM

INVENTORY NO. N.Y. 90

**PHASE I INSPECTION REPORT
NATIONAL DAM SAFETY PROGRAM**

SEPTEMBER, 1978

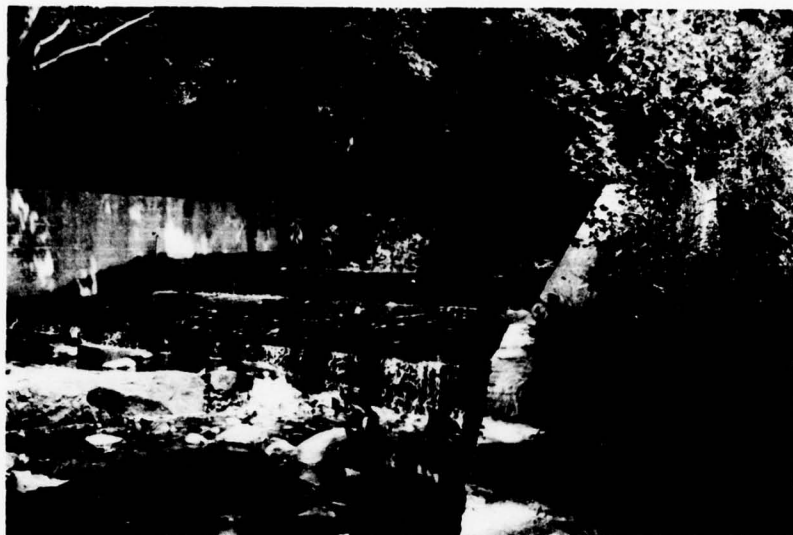
The spillway is in satisfactory condition. Two cracks in the east wall have been repaired. There were four sockets in the crest of the concrete spillway and anchor bolts on the side walls where supports for flashboards may have been located at one time. A pipe extending about two feet above the spillway crest was located in one socket on the west end. There was no other evidence of flashboards being used.

1. The embankment material behind the east wall of the spillway has settled or eroded away and is approximately 18 inches below the top of the concrete wall.

2. Brush is growing on the west side of the lake near the entrance to the spillway. A large piece of wood was laying in front of the entrance to the spillway.

SPILLWAY AND APRON
(Looking West)

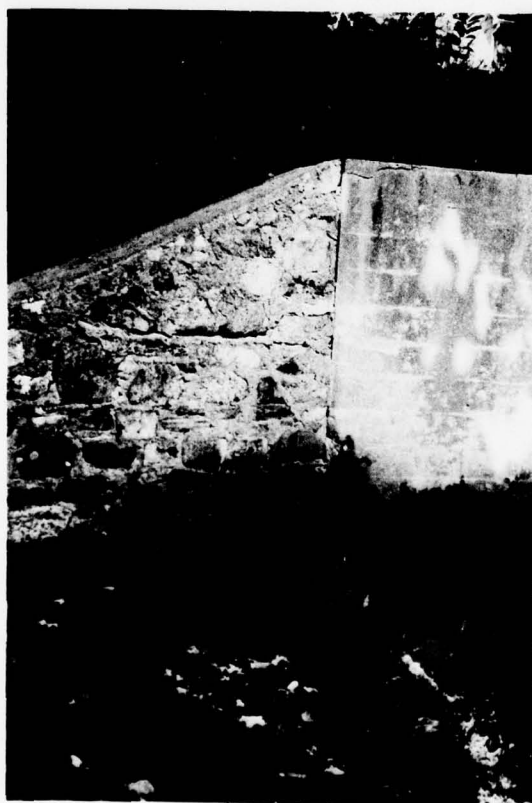
SPILLWAY CHANNEL WALL-SPILLWAY WALL
(Looking West)
